Summer 2023 Control Methods Test (CMT) Implementation and Interim Results:
Special Report¹
Prepared by: Dr. Lars Anderson

YEAR 2 CMT INTERIM REPORT

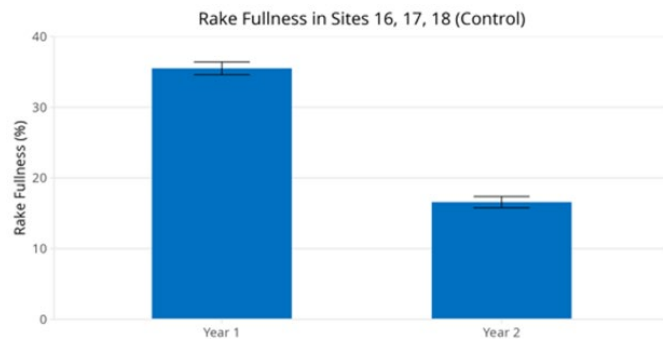
Figure 5. Comparison of average “Rake Fullness” as a measure of aquatic plant abundance in three untreated control sites (16,17,18) in the West Lagoon in 2022 and 2023. (Data are from all rake samples done in both years within the control sites.) example of rake sampling in control sites is shown in Figure 6.

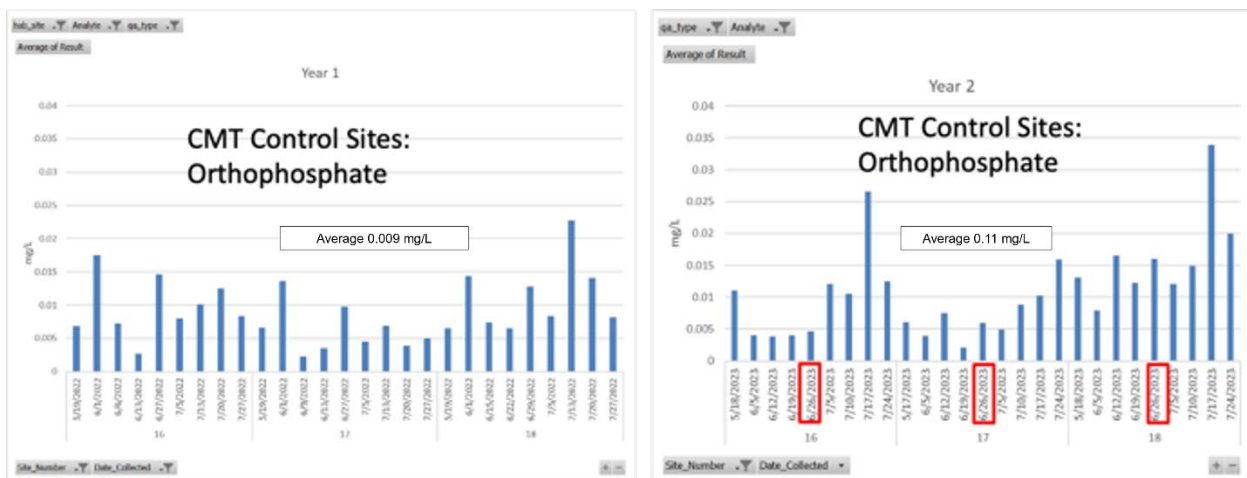
Figure 7. Comparison of orthophosphate in CMT Control Sites in 2022 and 2023.

The greater inflow of snowmelt into the lagoons in 2023 probably resulted in lower water column nitrogen and phosphorous levels in spring 2023 compared to spring 2022 (See examples of data in Figures 7-9). These levels, however, were still well above those in Lake Tahoe proper. As the 2023 season progressed, nutrient levels increased in the lagoons in general, but increases were not associated with continued use of the UV-Only (Group A) method. The Increased nutrients may be due to normal senescence of AIP mid-late summer.

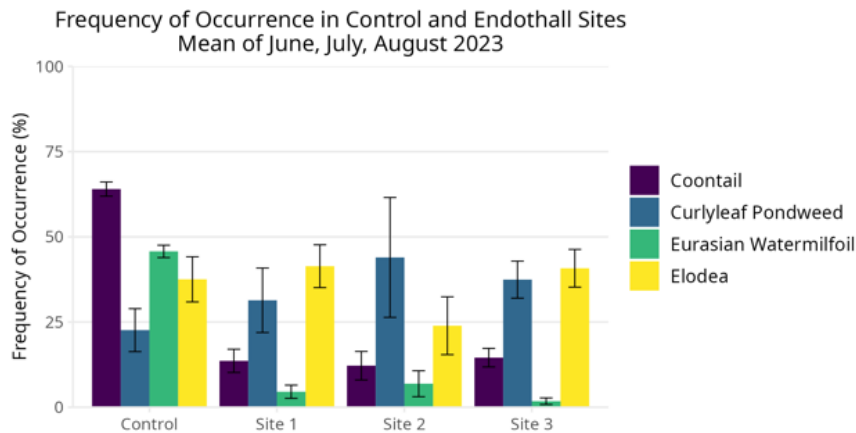
Figure 17. Three-month average (June, July, August) frequency occurrence of plants in Year 1 Endothall-Only treated sites in 2023 compared to control Sites 16,17,18.

Examples of Year 1 Endothall treatments and Year 2 monitoring are provided in Figure 16 for Site 1, and the 3-month average frequency of plant occurrence in Figure 17 for Sites 1,2 and 3. Note that in 2023, with no further herbicide treatments, the density of all target plants remained lower than in untreated controls on most sampling dates.

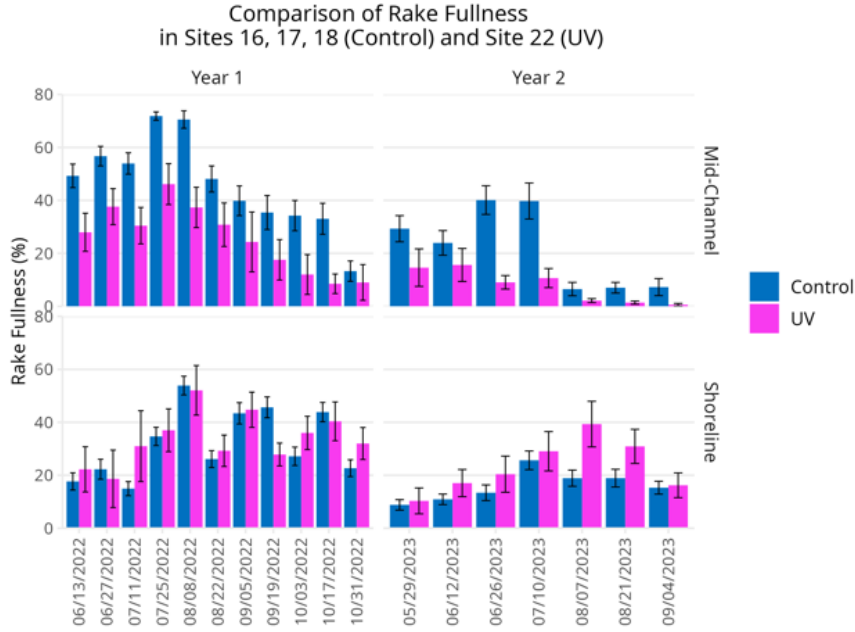
Figure 19. Effect of UV-Only treatment on Rake Fullness in Site 22. Rake data are separated by mid-site and shoreline areas.

Full site treatments with UV began in 2022 and were continued in 2023 in Sites 22 and 24 at 3-to-4-week intervals. (Note: Site 23 received only one UV treatment early in Year 2 and was then discontinued due to limitations on resources.) The UV system is most efficient in open water where plant exposure to UV is reliable and where positioning of the UV array is not impeded by various structures, shallow areas, and moored or docked vessels. To assess UV effectiveness, the Rake Fullness data (as surrogate for biomass) were used to compare middle and nearshore plant biomass following UV treatments in Site 22 and Site 24. The graphs for Sites 22 and 24 summarize UV treatments results and illustrates that shoreline areas were less well controlled with UV and that middle, open areas can be better controlled by UV. When the shoreline data are included as areas also targeted for control, the UV overall treatments are clearly not as effective. These Rake Fullness data also are consistent with the hydroacoustic scans of Site 22 and show that the UV treatments were effective in reducing plant density in both 2022 and 2023 in the middle site areas (Figures 19 and 20). However, the nearshore samples showed that the Rake Fullness in and around dock areas was higher. The 3-month average frequency of occurrence (Figure 21) shows that coontail was consistently the dominant species. The effectiveness of UV in Site 22 can also be seen in the detail (closeup) of the hydroacoustic scan from August 25, 2023 (Figure 22-B). The scans also produce a visual representation (“side view”) of Site 22 as shown in Figure 23. Note the clear demarcation of untreated areas where plant profiles are abundant compared to sparse plants as the scanning boat entered the UV treated area of Site 22.

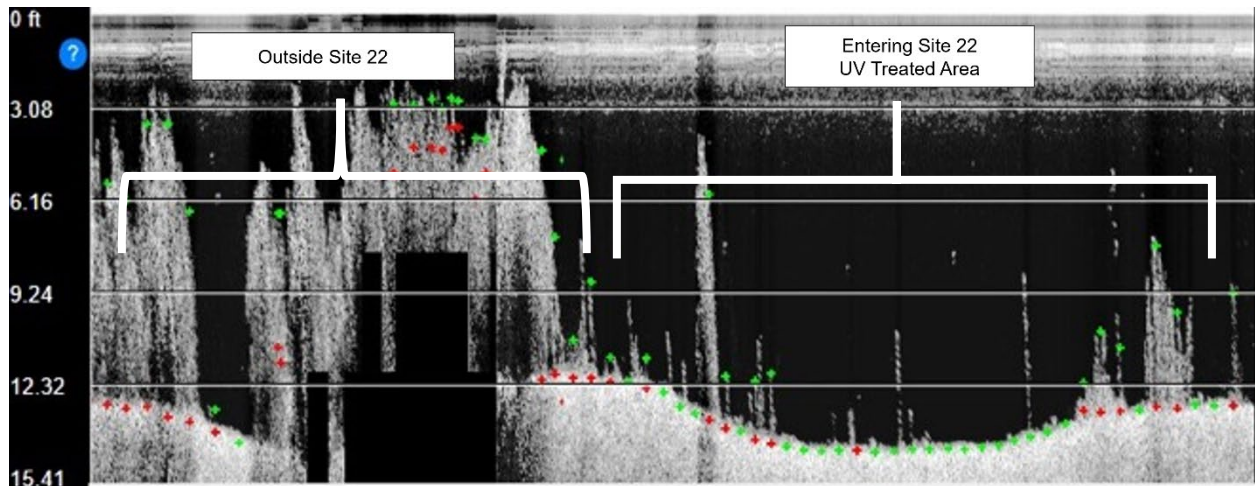
Figure 23. Hydroacoustic scan-generated side-view image in UV-Only Site 22 just outside (left side of image) with dense plants compared to sparse plants resulting from UV-treatments in the area on the right side of the image.

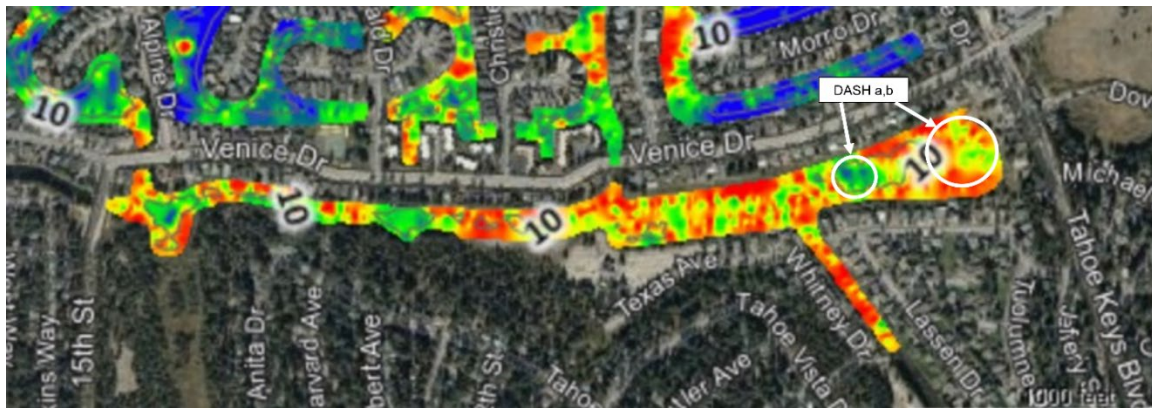
Figure 34. Hydroacoustic scan of Lake Tallac made August 24, 2023. The circles show the locations of the two DASH areas and the relatively low biomass (green) compared to the rest of Site 19. (See Figure 1.)

However, the hydroacoustic scan done August 24, 2023 shows that plants in Lake Tallac had become dense, but there are two “green” areas in Site 19 that correspond to the DASH treatments, which indicates that the biovolume was reduced by DASH. (Figure 34). The Rake Fullness data from the DASH areas are shown in Figure 33.

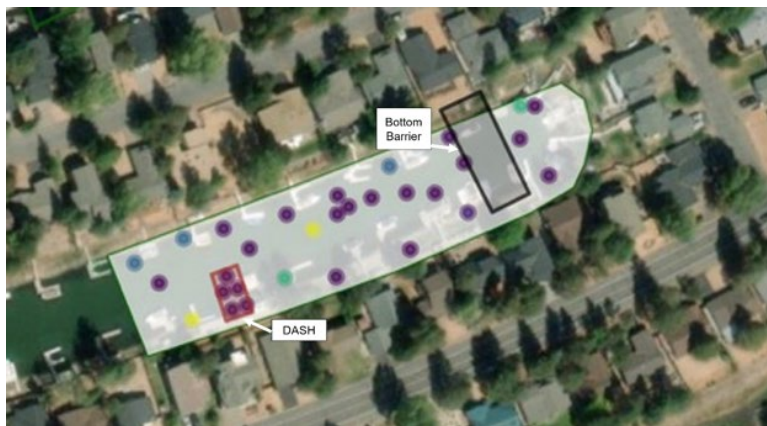
Figure 35. Site 8 (Year 1 Triclopyr-Only) showing DASH area and Bottom Barrier area. The sample points are from September 5, 2023. Note the cluster of sample points within the DASH area.

Sites 8 (Year 1 Triclopyr-Only) had DASH and Bottom Barrier methods. (Figure 35). The September 5, 2023 sampling in Site 8 showed that DASH reduced plant Rake Fullness to 0% compared with Rake Fullness of 16.0% in the non-DASH area. The DASH was very effective in removing aquatic plants within the designated area (Figure 36) (Note: The Bottom Barrier in Site 19 was removed in early October and will not be surveyed for AIP abundance and presence until late October and early November).

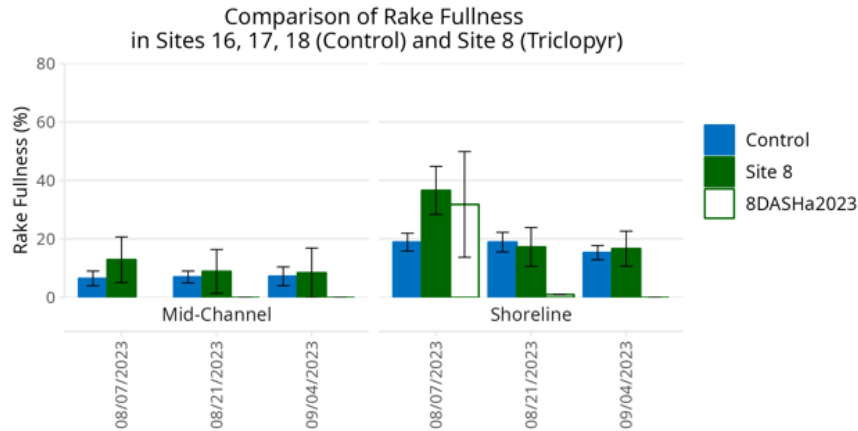
Figure 36. Site 8 Rake Fullness comparing DASH site with Non-DASH within Site a (“Site 8” in legend), and West Lagoon Control sites 16,17,18 (“Control” in Legend).

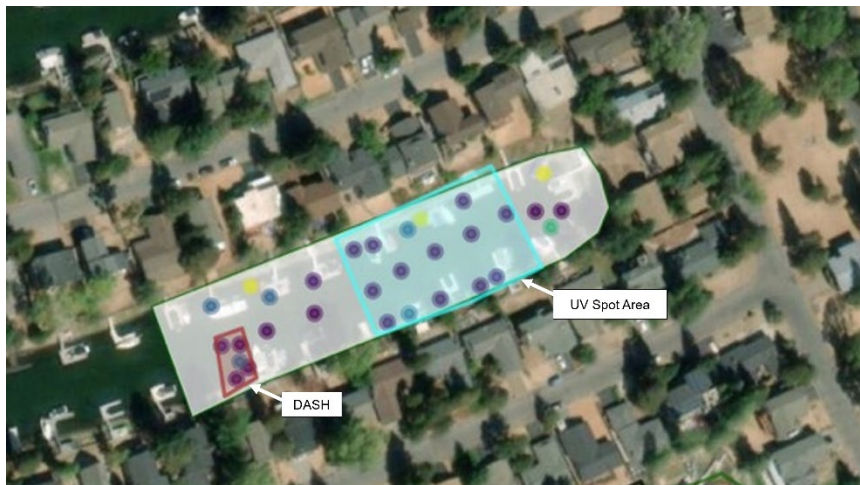
Figure 37. Site 9 (Triclopyr-Only Year 1) showing the DASH area and UV Spot area and rake sample points on September 5, 2023.

Site 9 (Year 1 Triclopyr-Only) had a DASH area and large UV Spot Treatment area (Figure 37). The rake samples taken September 5, 2023 showed that Rake Fullness in the UV Spot area was reduced to near zero compared to the surrounding Non-UV mid-channel Rake Fullness of 26 (Figure 38). If the rake samples in Non-UV areas included the shoreline zones, then the UV Spot treatment only reduced the Rake Fullness to 9.0% from 26%. This illustrates the enhanced UV efficacy typically achieved in the mid-channel areas of sites, compared to shallower shorelines where structures may limit UV- vessel access.
